A COMPARATIVE EVALUATION OF THREE POTENTIAL
ICE RESCUE VEHICLES

BY: LTJG JOHN A. BUDDE, USCGR

SEPTEMBER 1982

FINAL REPORT

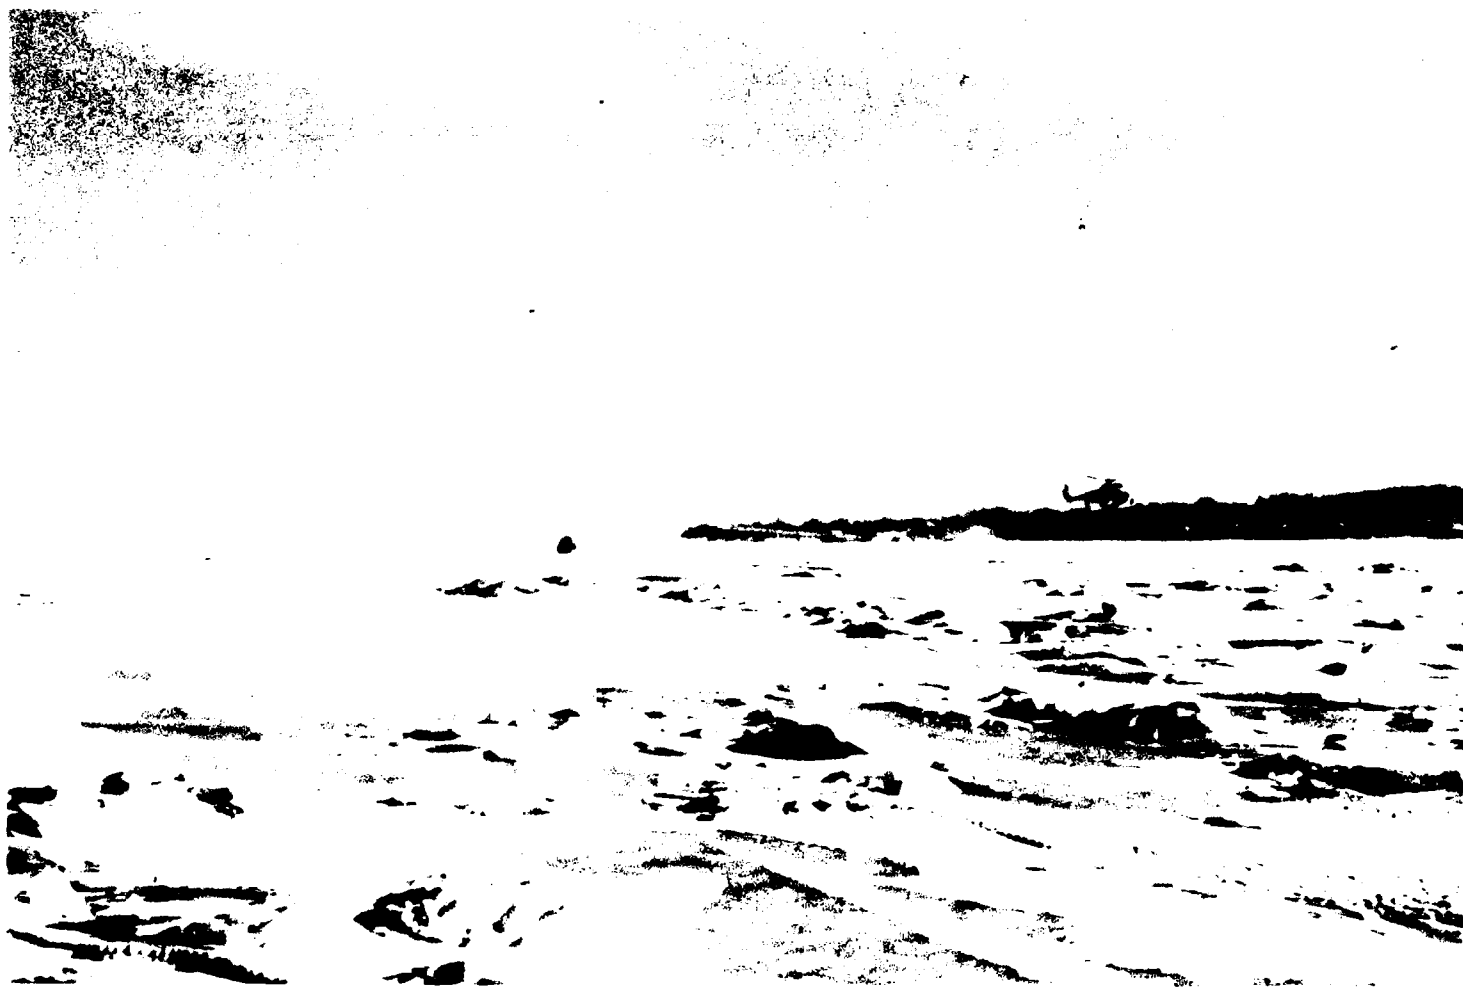
Figure 1.4 A photograph of pressure ridging on Lake Erie. The photograph was taken within a mile of Station Marblehead, Ohio in January 1982.

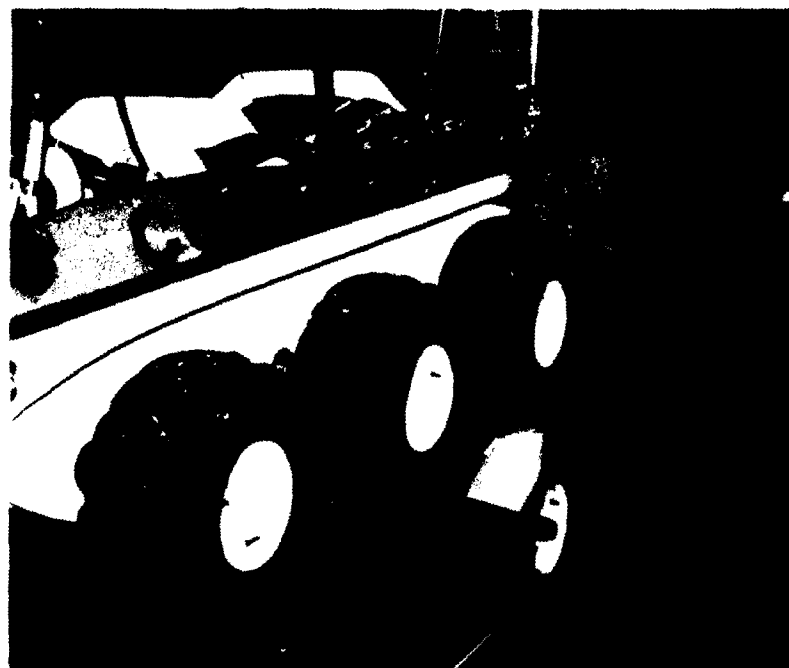
Figure 2.6 Side view of the ATV showing the studded, rawhide tires.

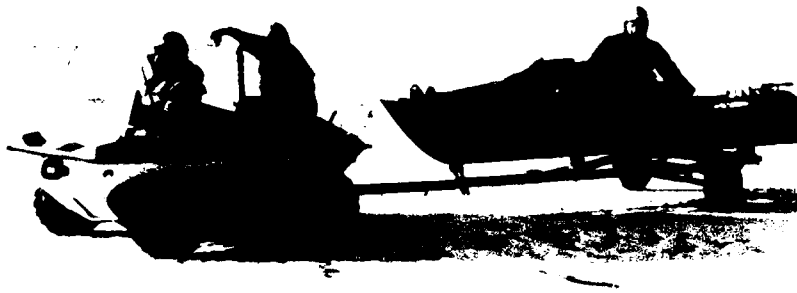
Figure 5.3 The ATV underway during the trials. The flat tire on the trailer is visible in the picture.
